# **055 – NORWEGIAN OIL AND GAS RECOMMENDED GUIDELINES**

**NDT OF GRP PIPE SYSTEMS  
AND TANKS**

## **GUIDELINE FOR NDT OF GRP PIPE SYSTEMS AND TANKS**

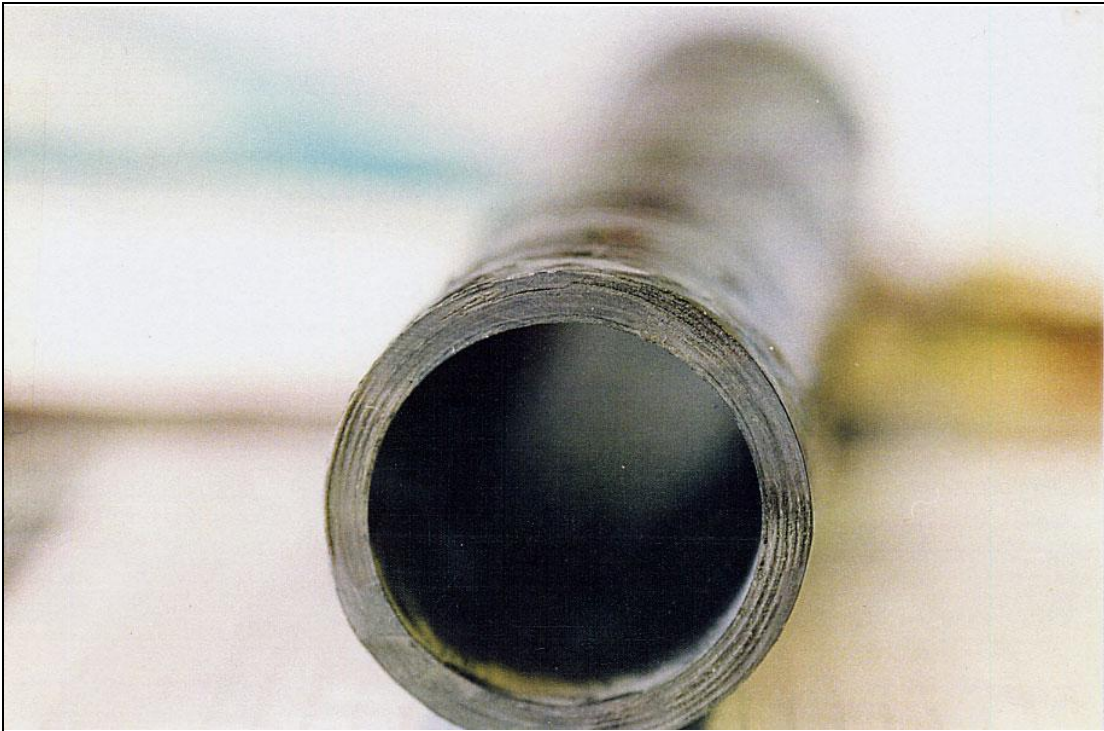
**FIG. A1: Delamination, internal.  
Caused by improper curing (residual cure stresses resulting in cracking and delamination)**

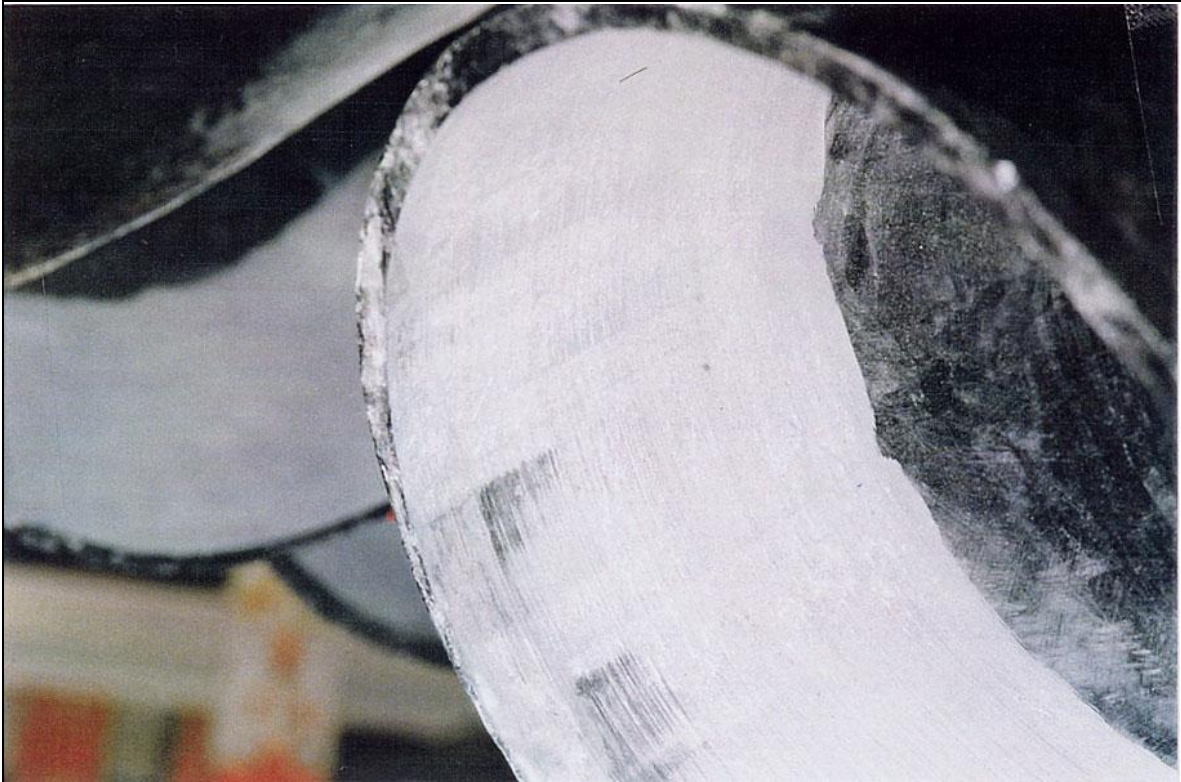
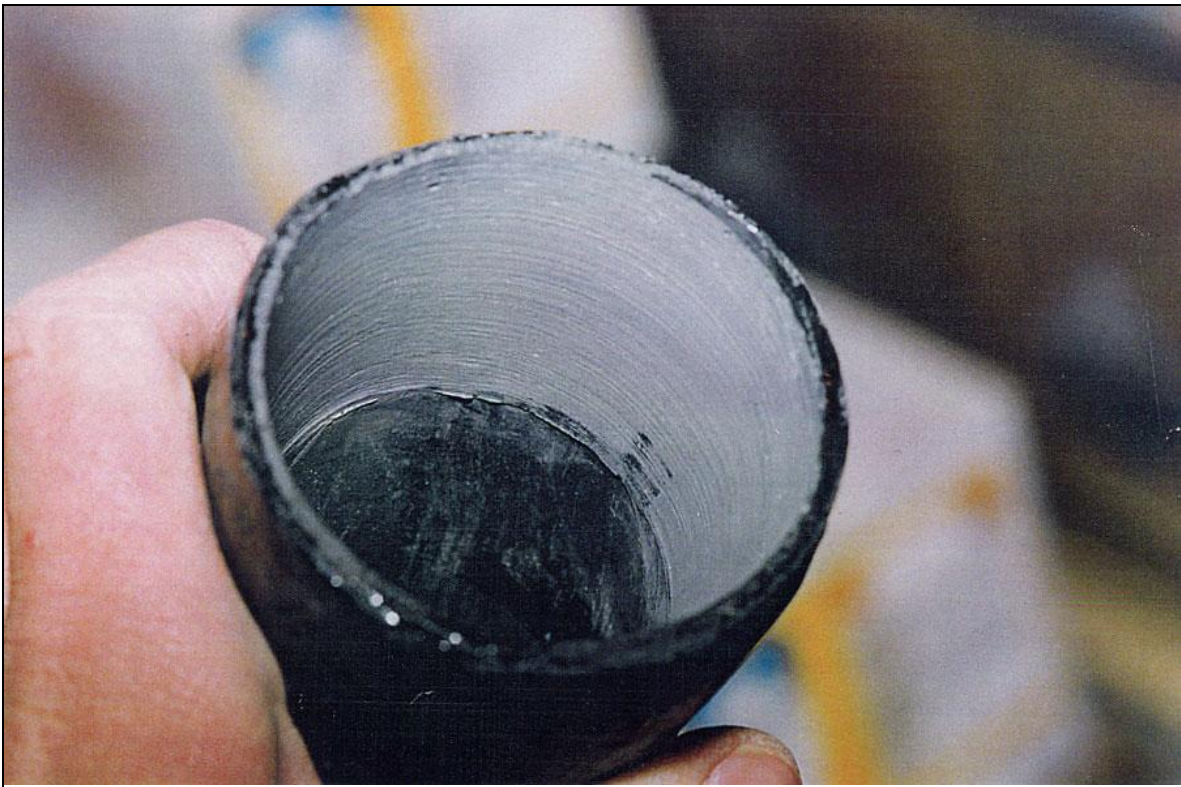
**FIG. A2: Incorrect dimensions.**

**Uneven wall thickness after grinding of adhesive joint surfaces.**

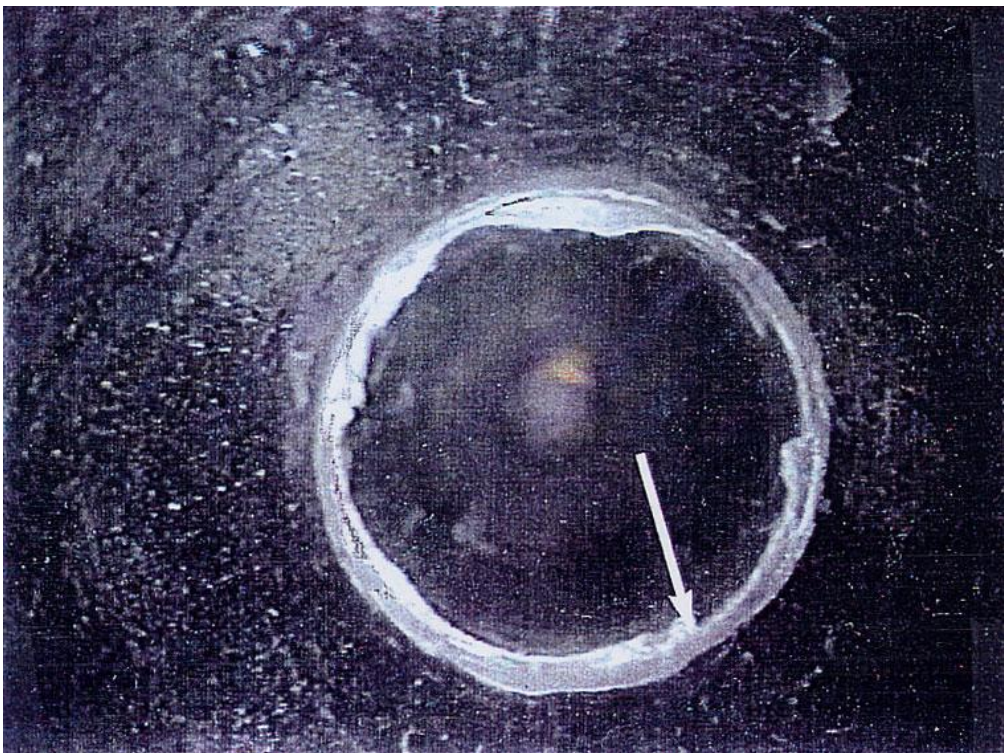
**FIG. A4: Excessive adhesive, internal. Illustrating internal video inspection of a couple-jointed GRP pipe with excess adhesive.**

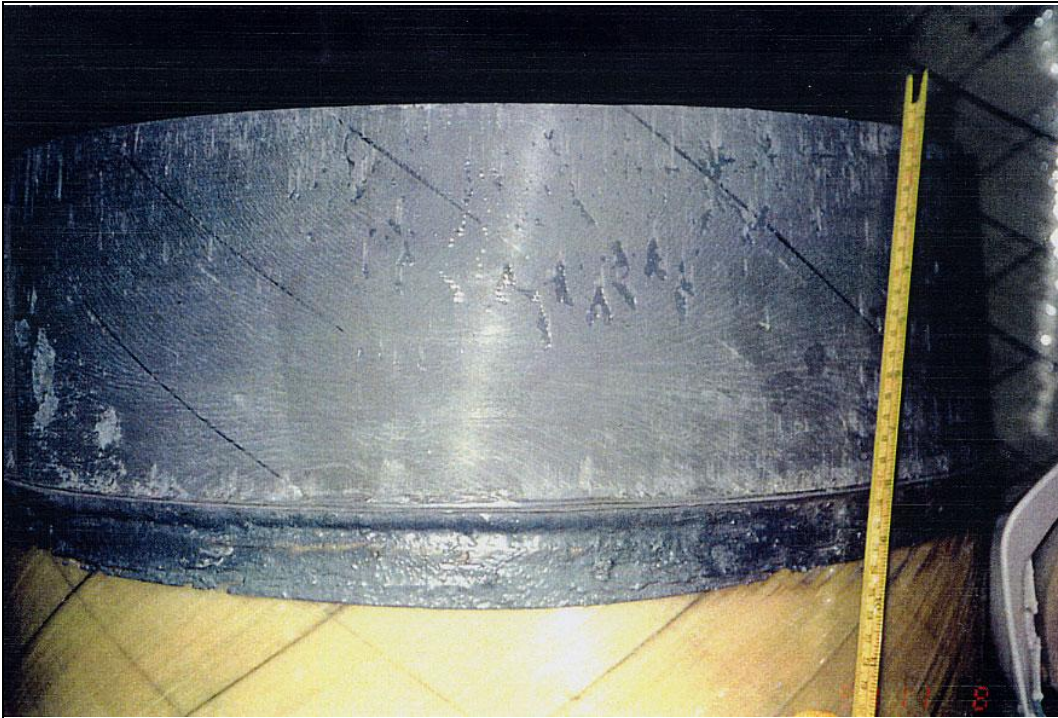
Taper spigot-end of 24" pipe

**FIG. A7: Inadequate ("kissing") bond.**

**Caused by improper preparation of female surface prior to bonding. May also be caused by contamination of surfaces, improper resin mixing or curing etc.**

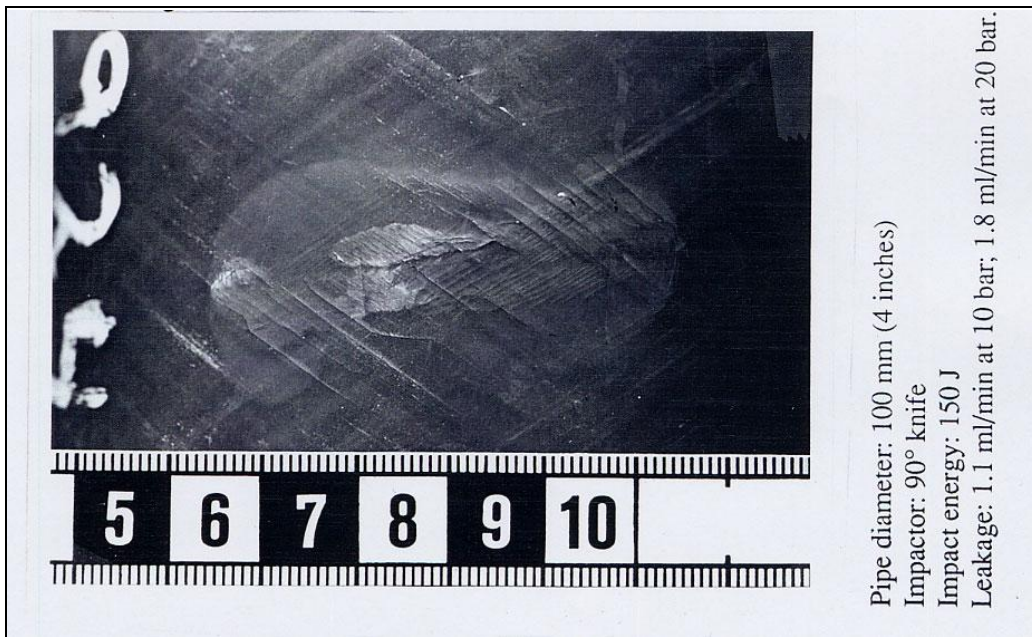
**FIG. A8: Cracks. Delamination. Impact damage.**

Combination of cracks and delaminations typical of impact damage. Shown here for increasingly severe damage (leakage rate) levels. Circular crack pattern in outer layers with little delamination can be seen for lower damage levels (A, C). Difference between hemispherical (A, C, D E) and sharp-edged impactors show that sharp-edged (B) often produce less extensive damage. Larger damage areas (lighter coloured delaminations and cracks following fibers) can be seen for increasing impact damage (D, E)

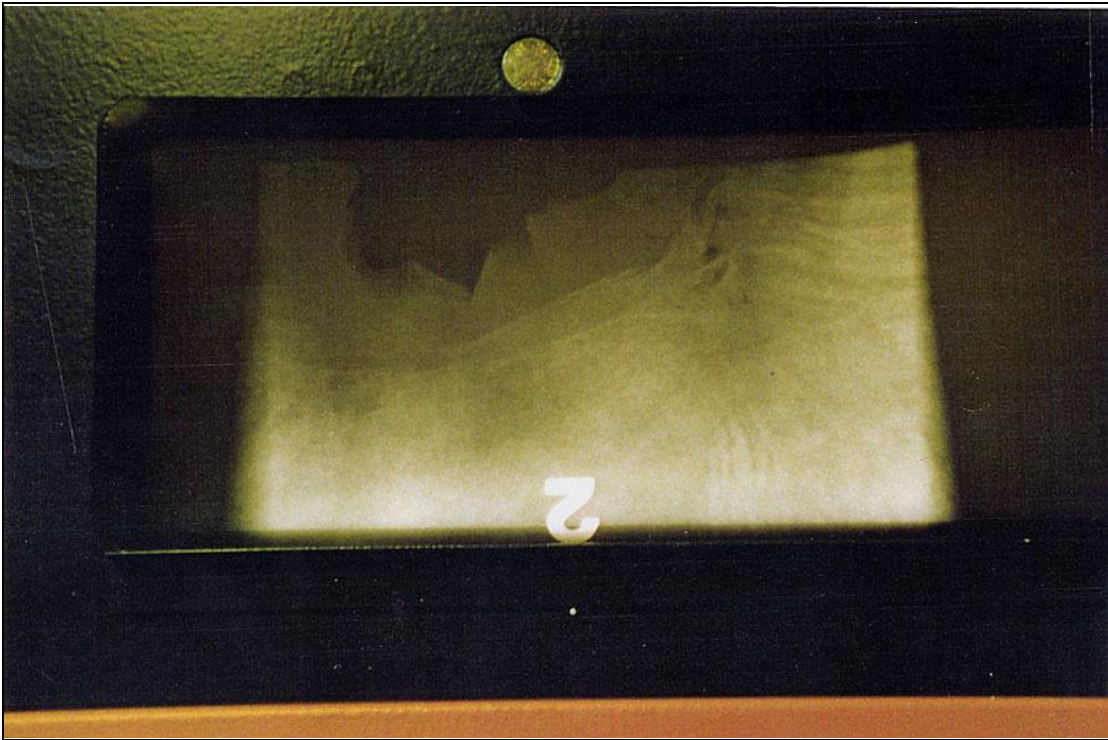
**FIG. A9: Incorrect resin/Fiber ratio.**

**Lack of fiber in laminate (shown in both x-ray and visual appearance)**

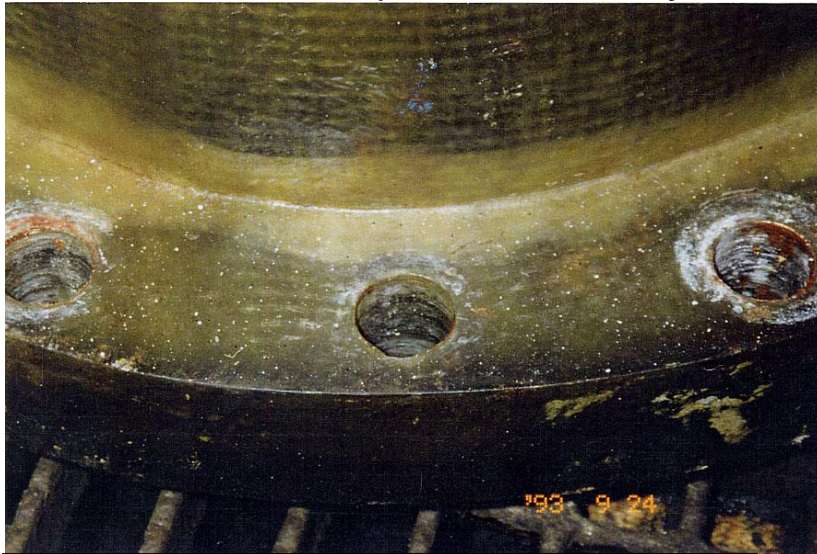
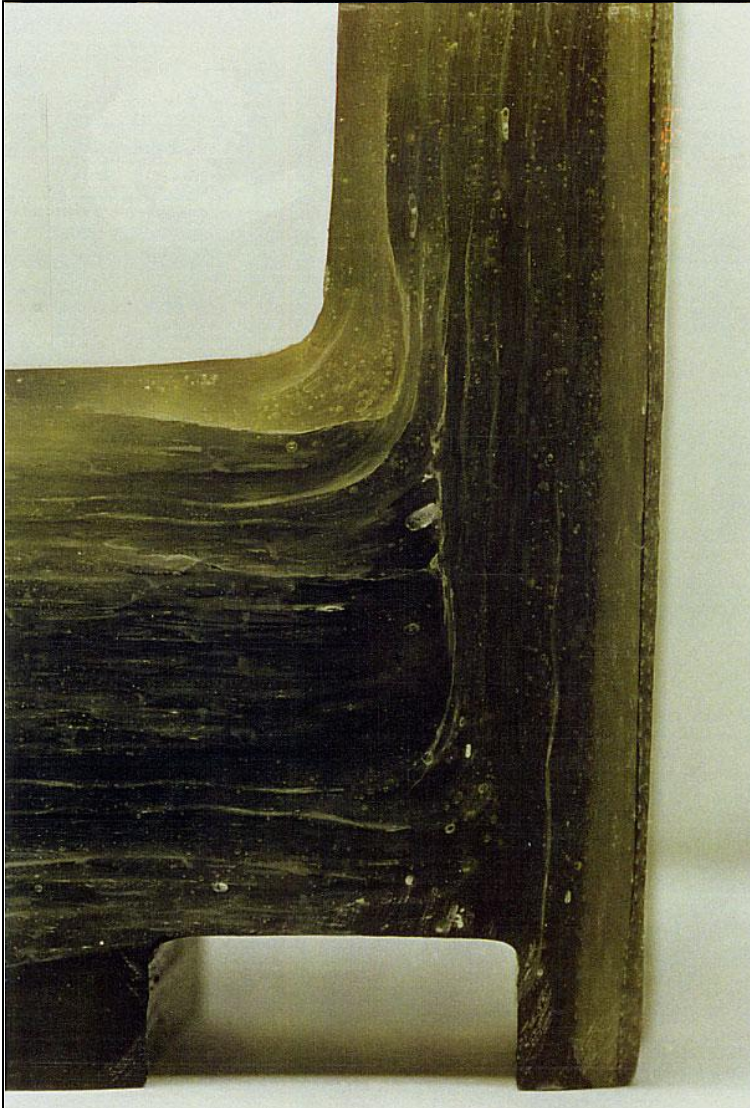
**FIG. A10: Delamination. Internal. Delamination in flange root (caused by stressing flange with plies layed-up using incorrect sequence)**

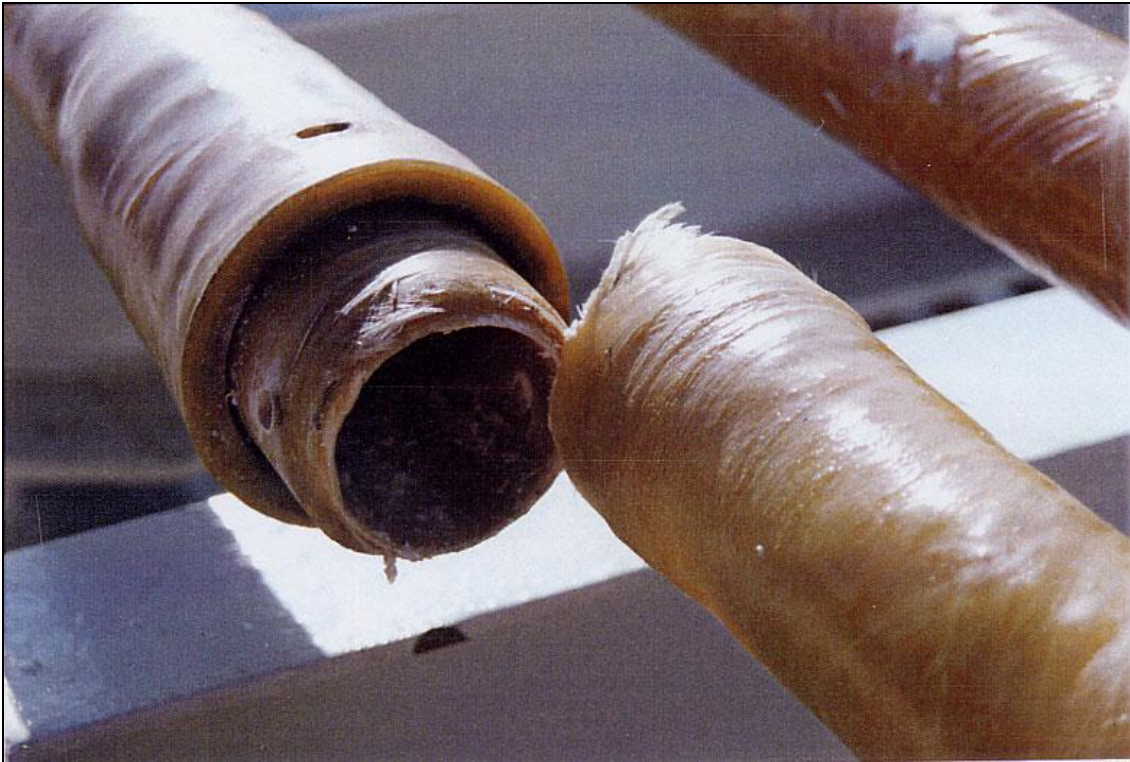
**FIG. A11: Fracture.**  
**GRP pipe ruptured at fitting (caused by improper fabrication, sufficient axial fibers missing)**

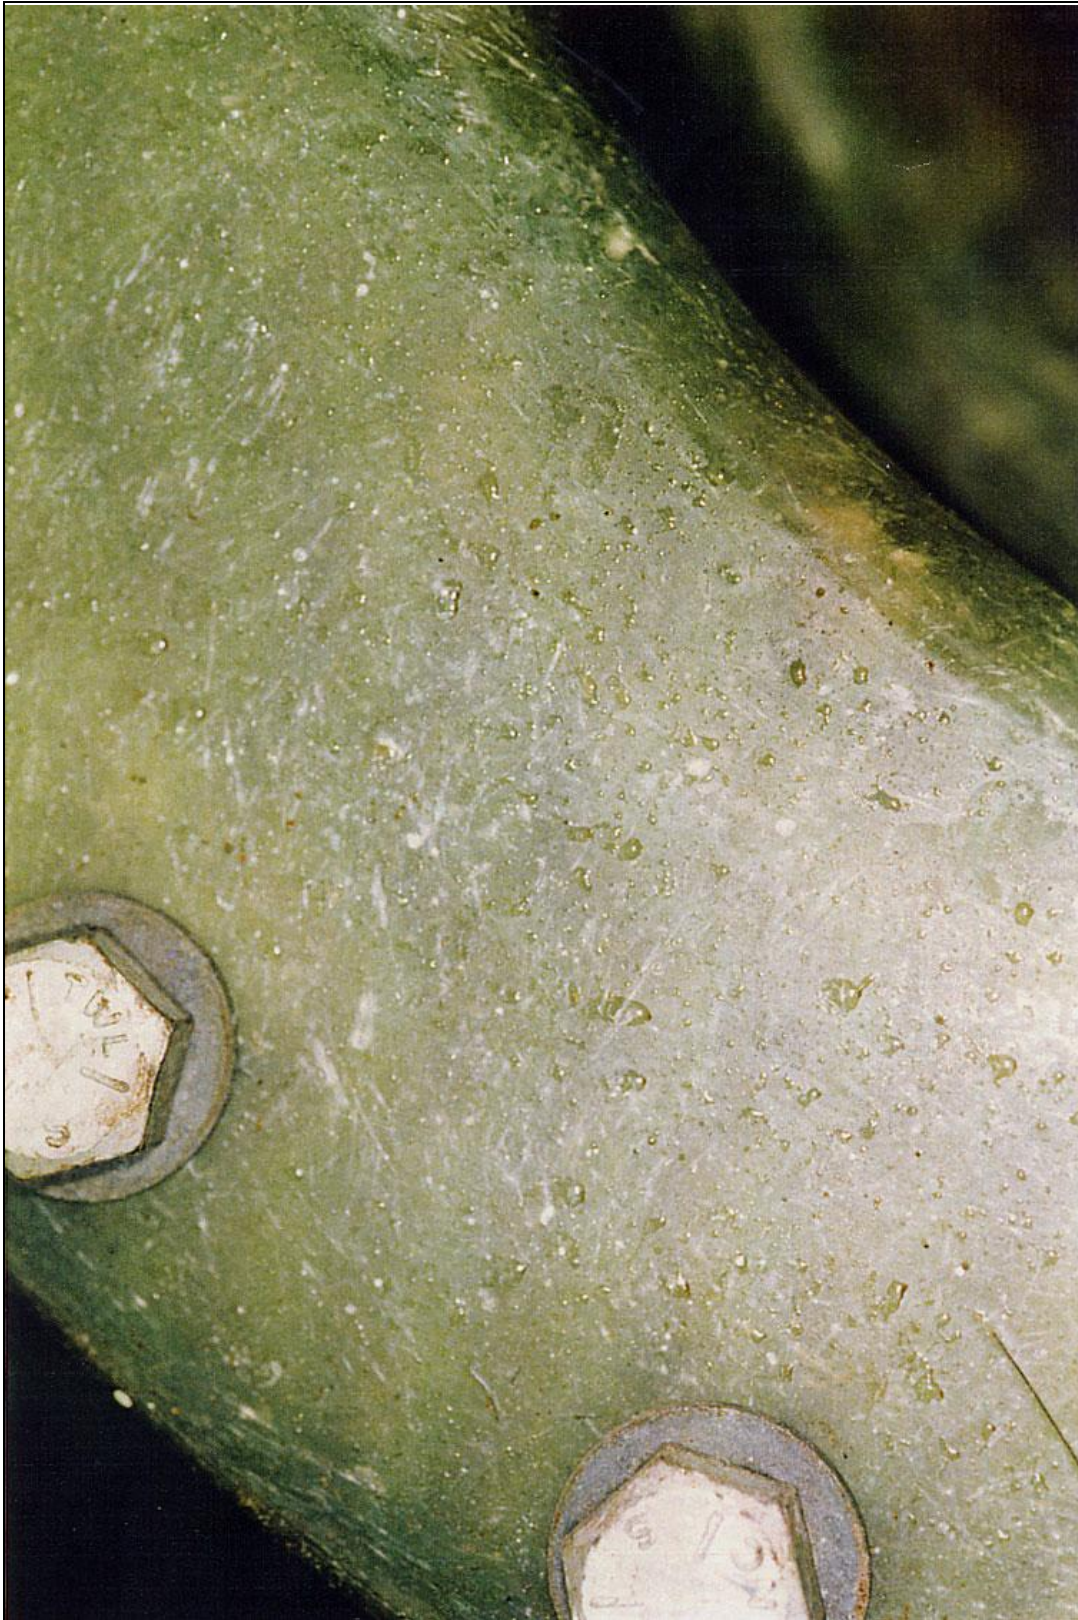
**FIG. A13: Weeping.**

**Weeping through laminate will appear this way, but will typically be more localized (since most GRP defects are localized). Picture shows condensation which can be confused with weeping. Surface being visually inspected should be dried and re-**

inspected if weeping is suspected.

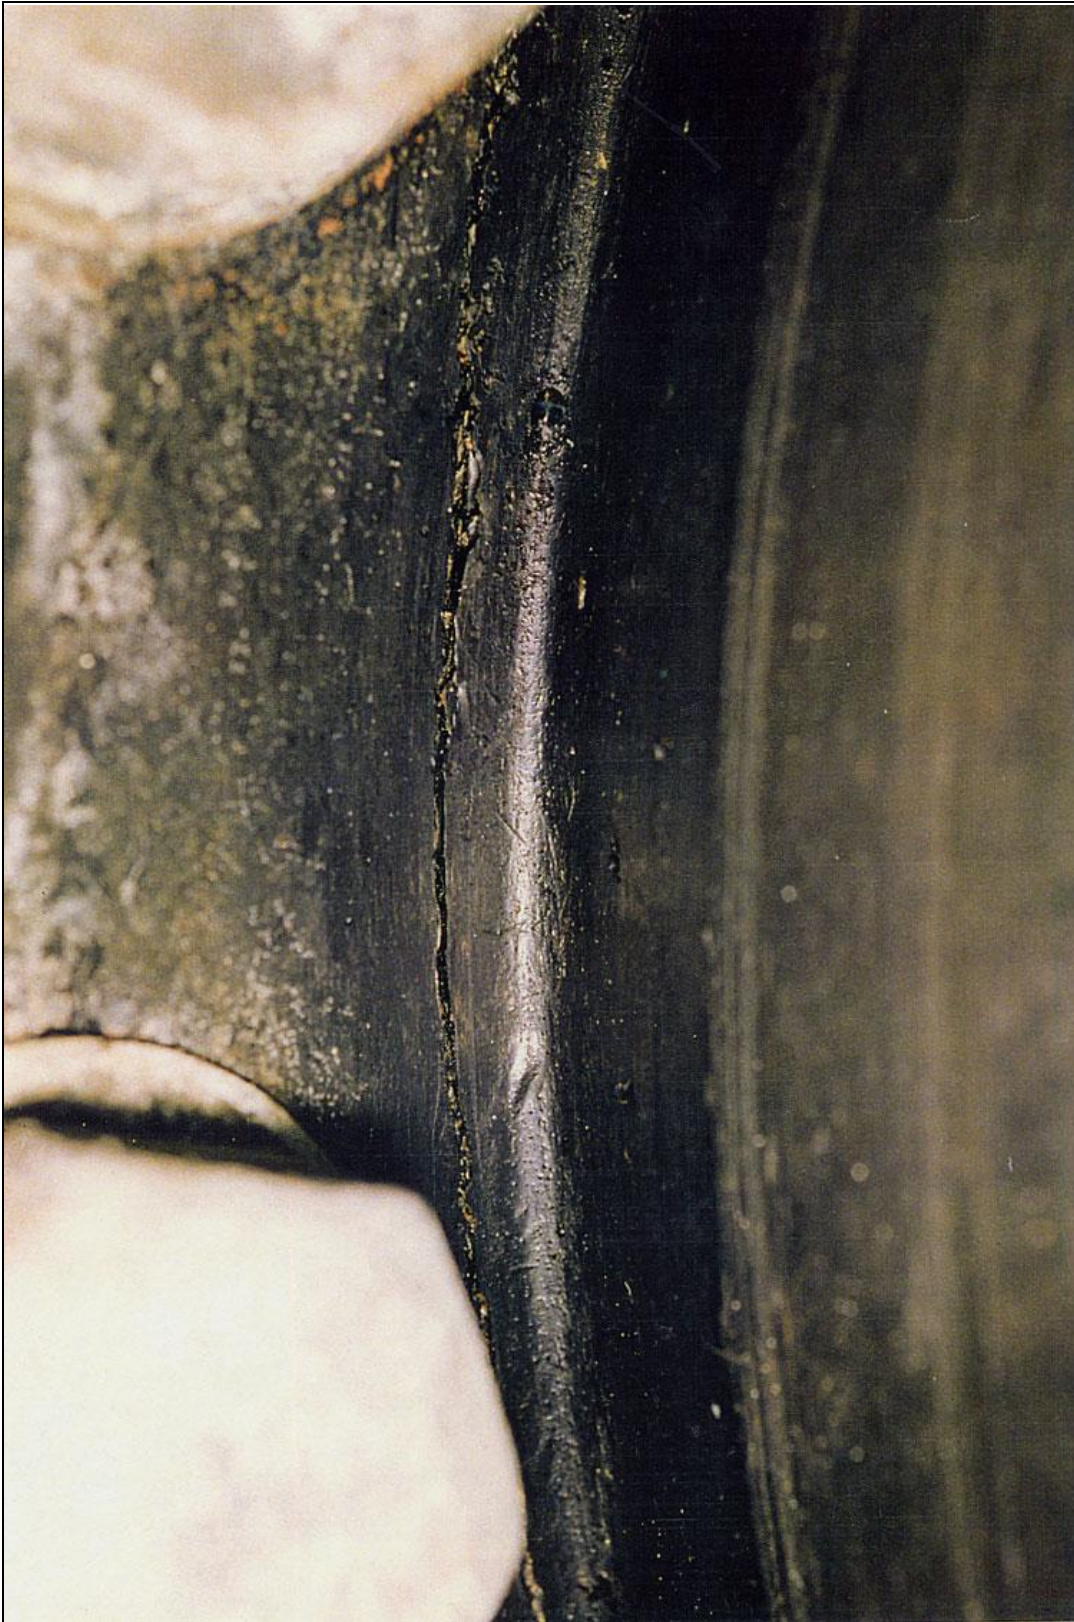
**FIG. A15: Crack, in flange root.  
Detail showing typical cracking (not same flange as FIG. A14)**

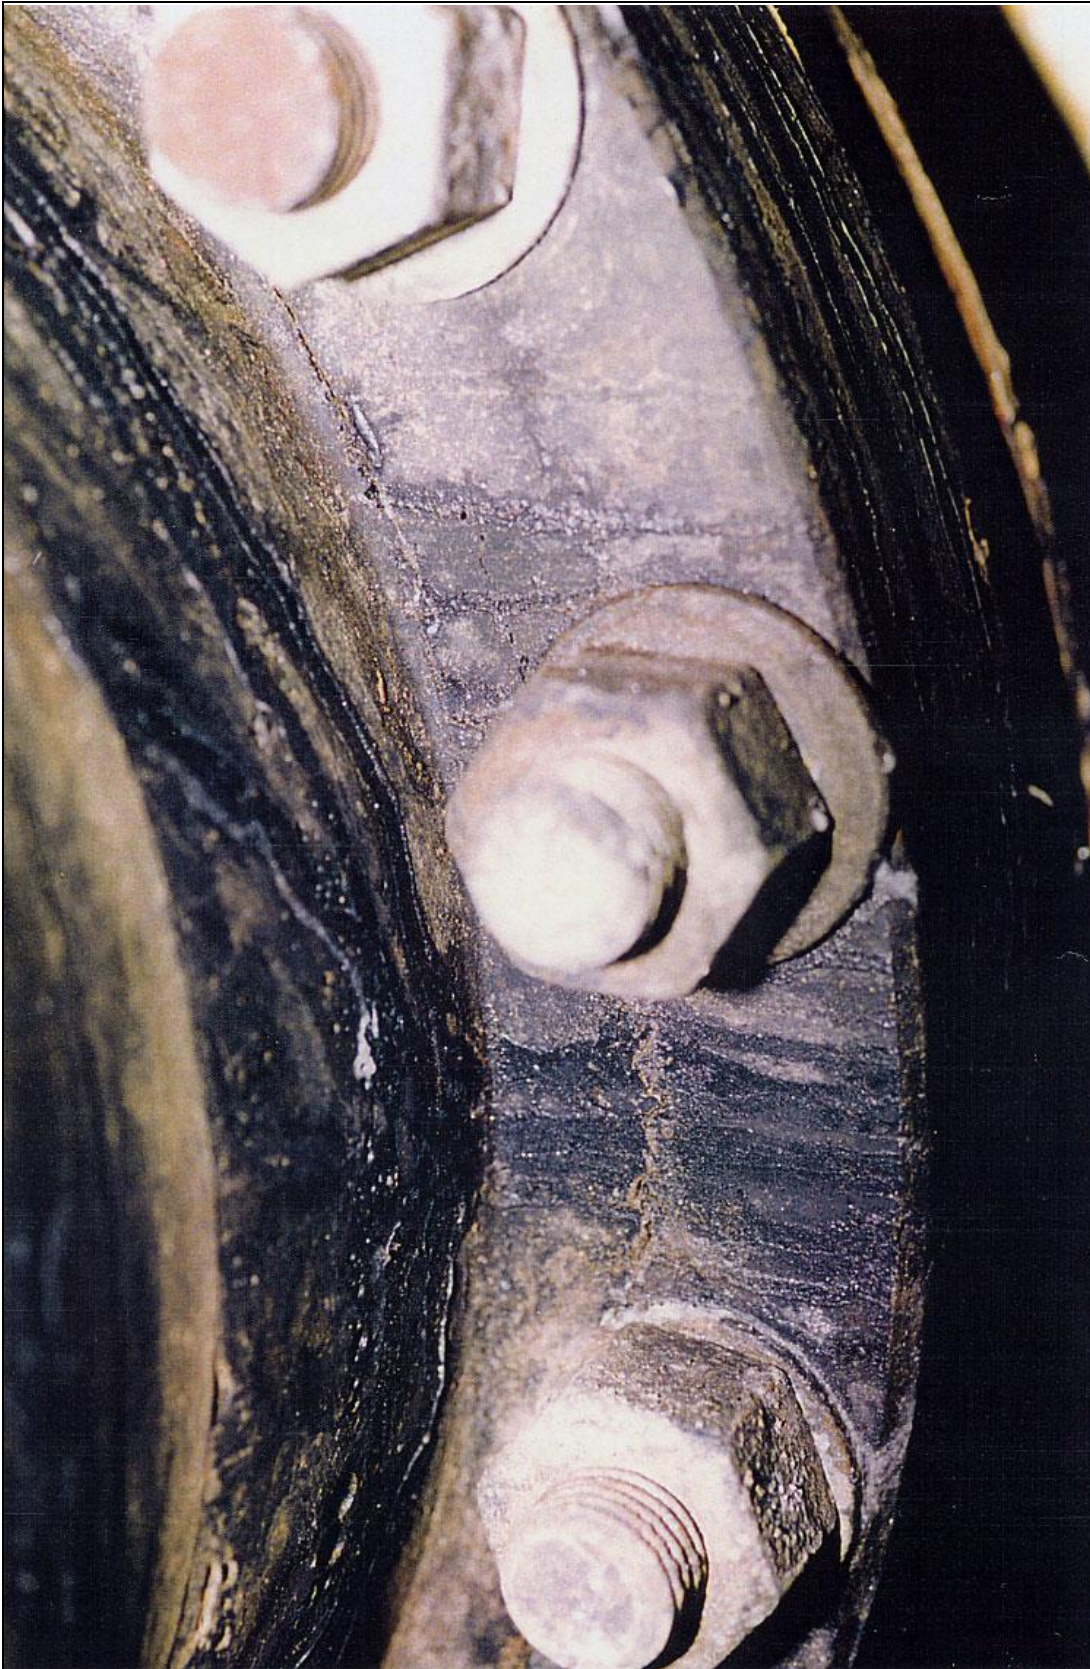
**FIG. A16: Cracks, in flange root and bolt ring. Cracking caused by overtorquing bolts or overstressing flange (white on surface is salt)**

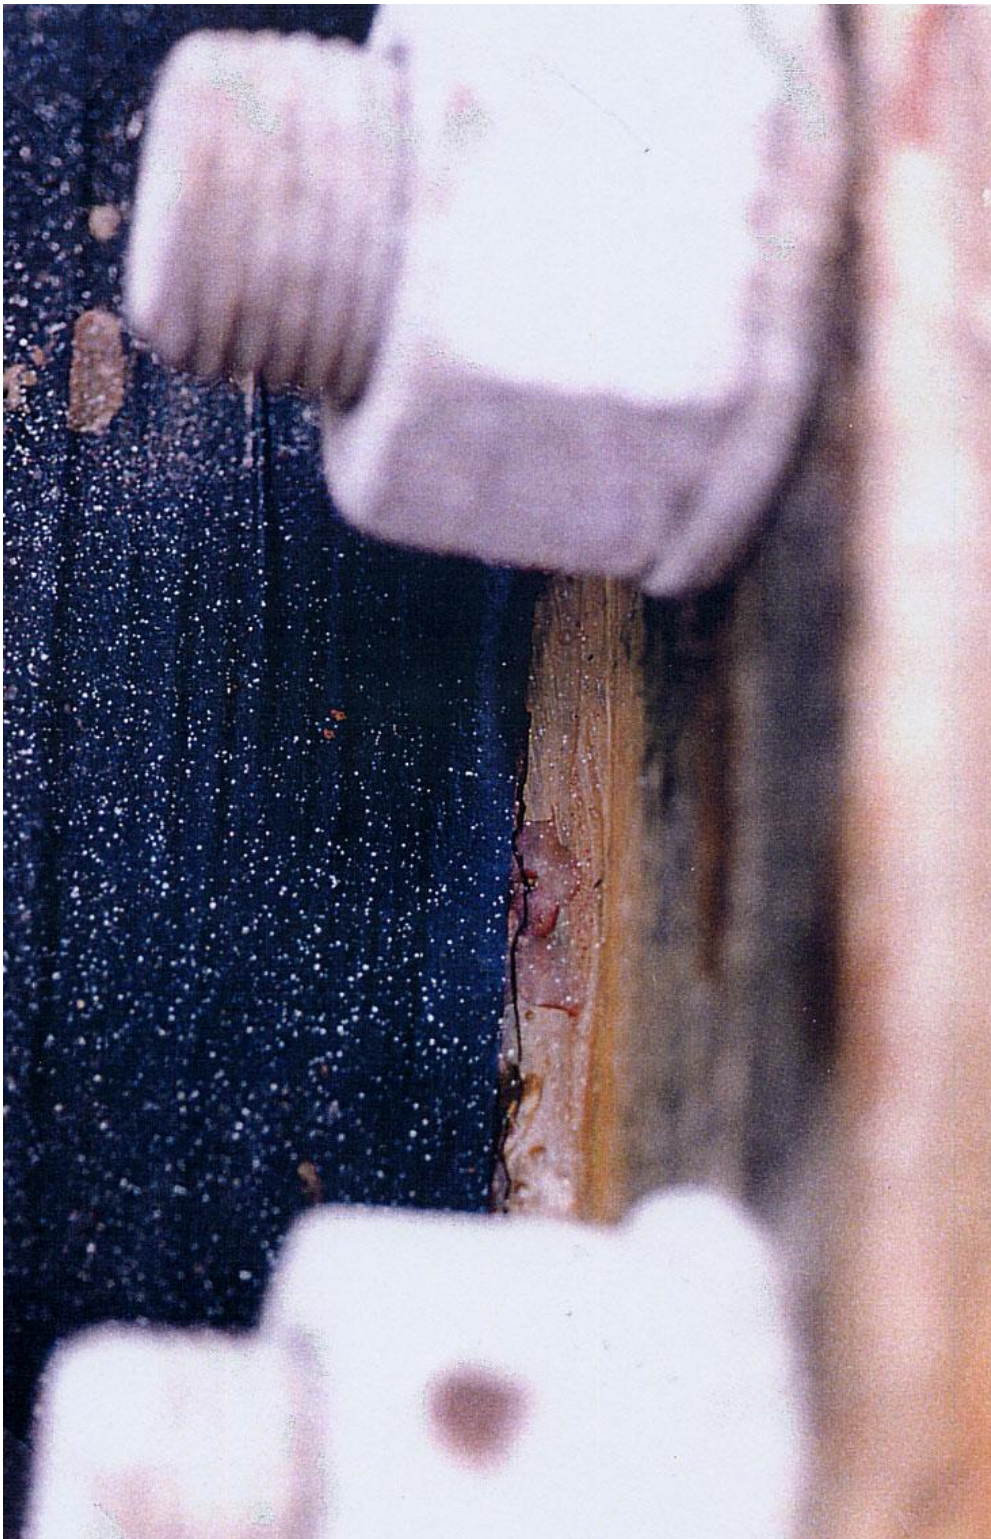
**FIG. A17: Crack, in resin-rich surface layer.  
(A) View of flange (white particles are snow)**

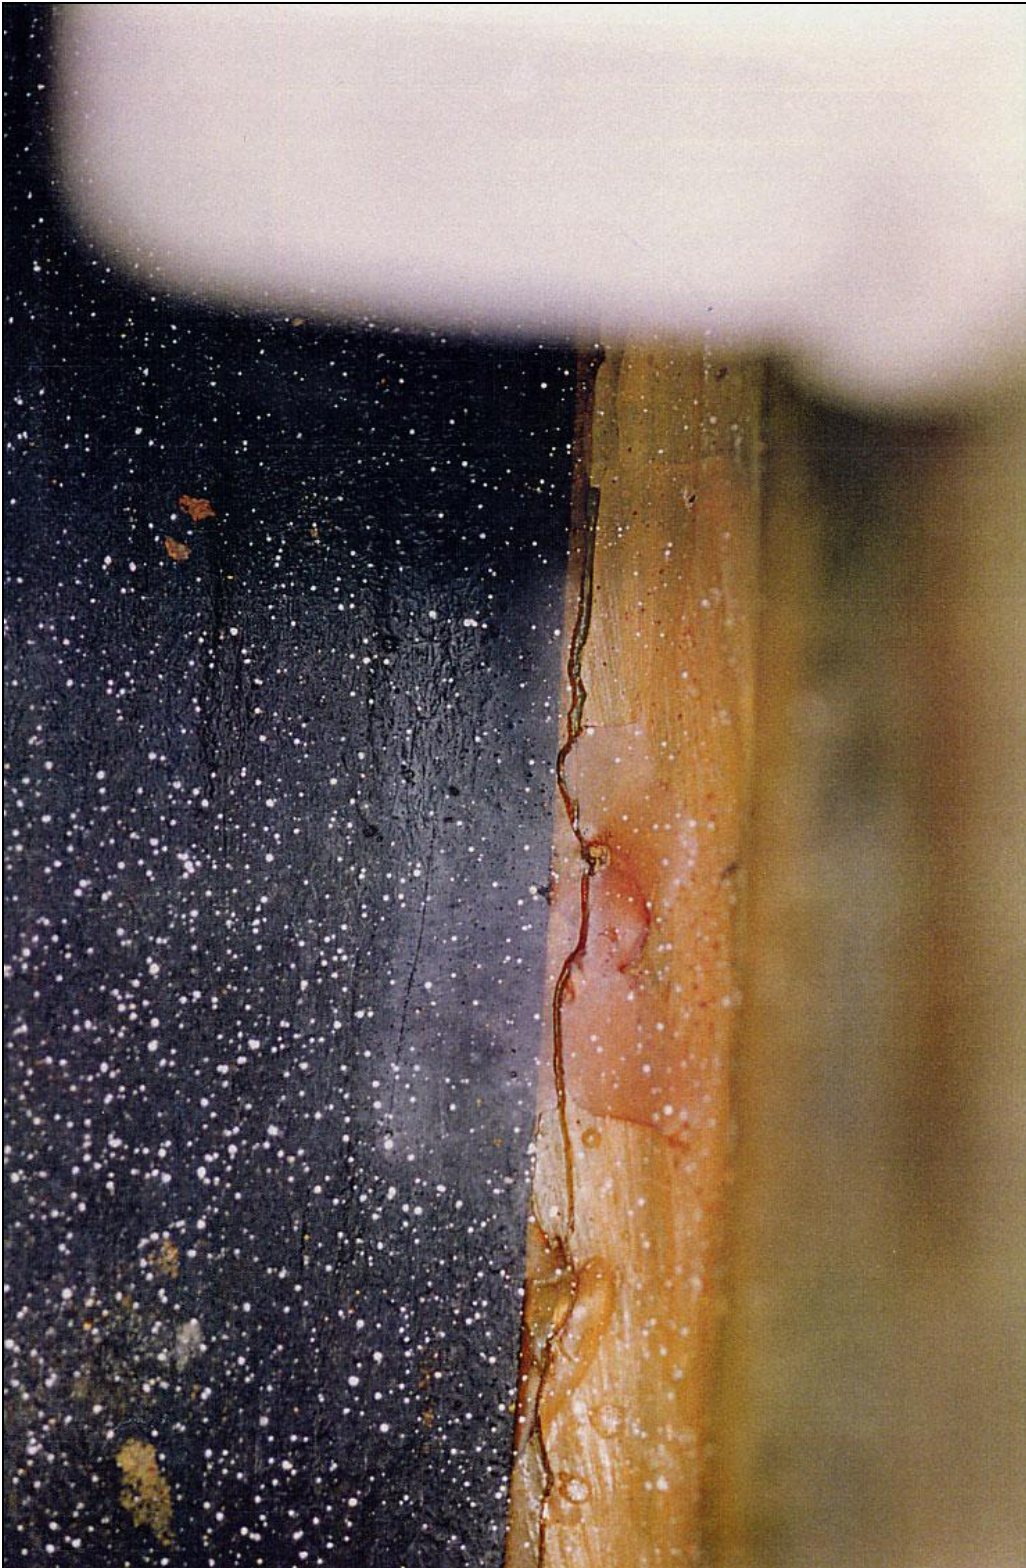
**FIG. A17: Crack, in resin-rich surface layer.  
(B) Close-up view showing crack depth to surface resin layer thickness (white particles are snow)**

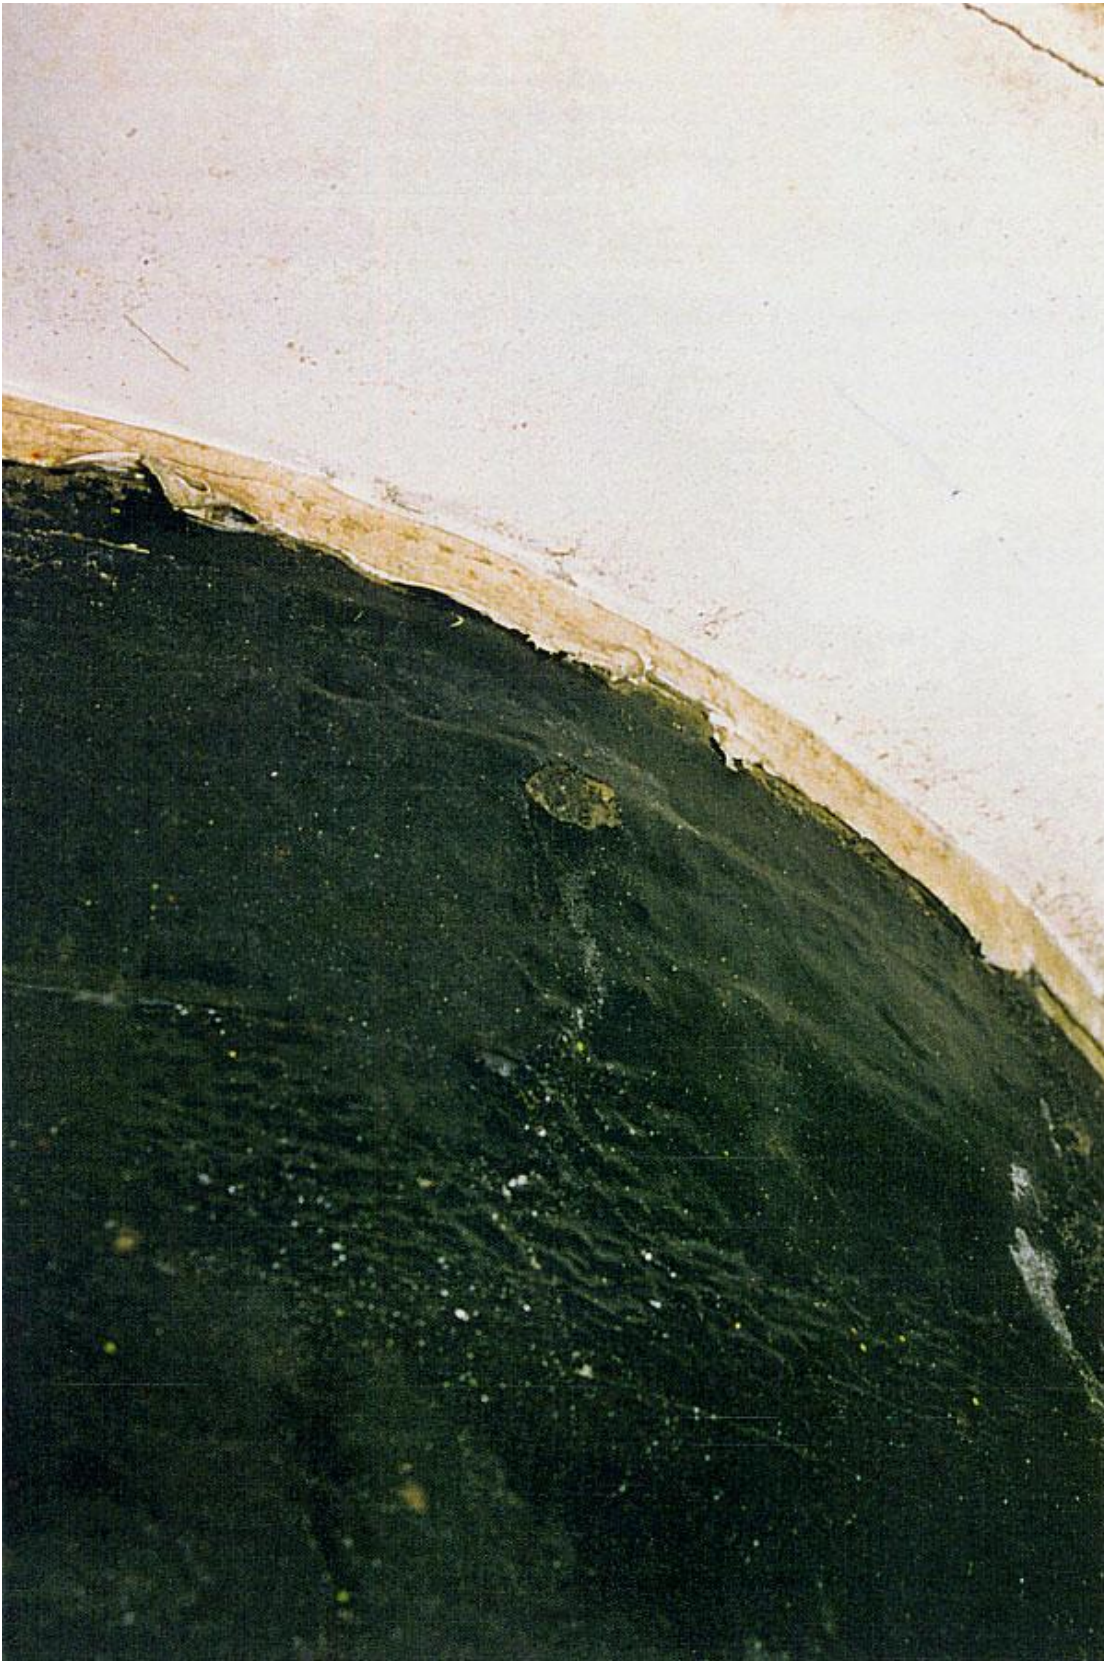
**FIG. A18: Chip.**

**Outer ply of laminate chipped off (may first have blistered in this case)**
